THE IMPACT OF FORESTRY ROADS
ON PEATLANDS WITHIN THE
TONGASS NATIONAL FOREST,
SOUTHEAST ALASKA

Paul H. Glaser

August 26, 1999

The Impact of Forestry Roads on Peatlands within the Tongass National Forest, Southeast Alaska

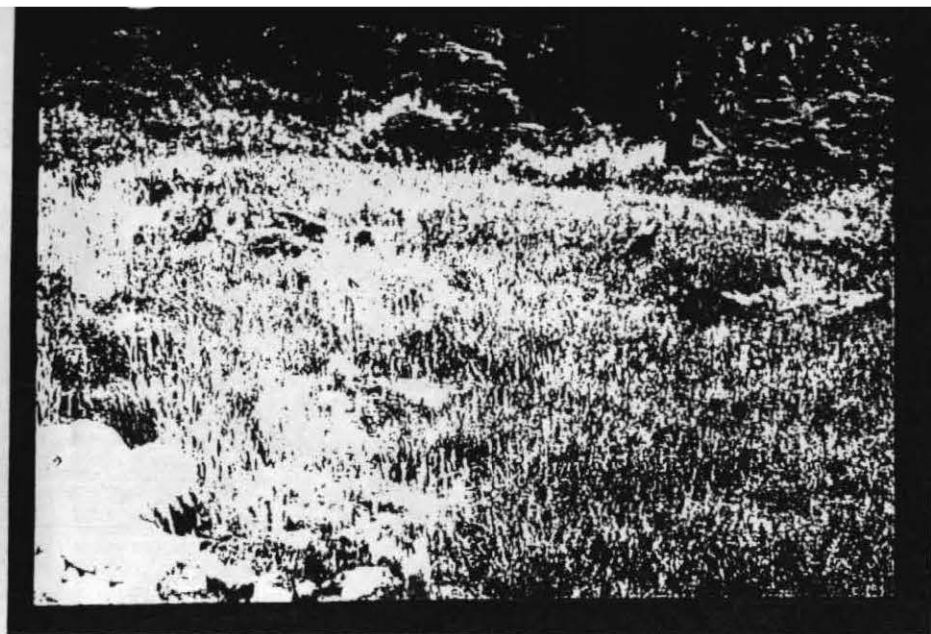
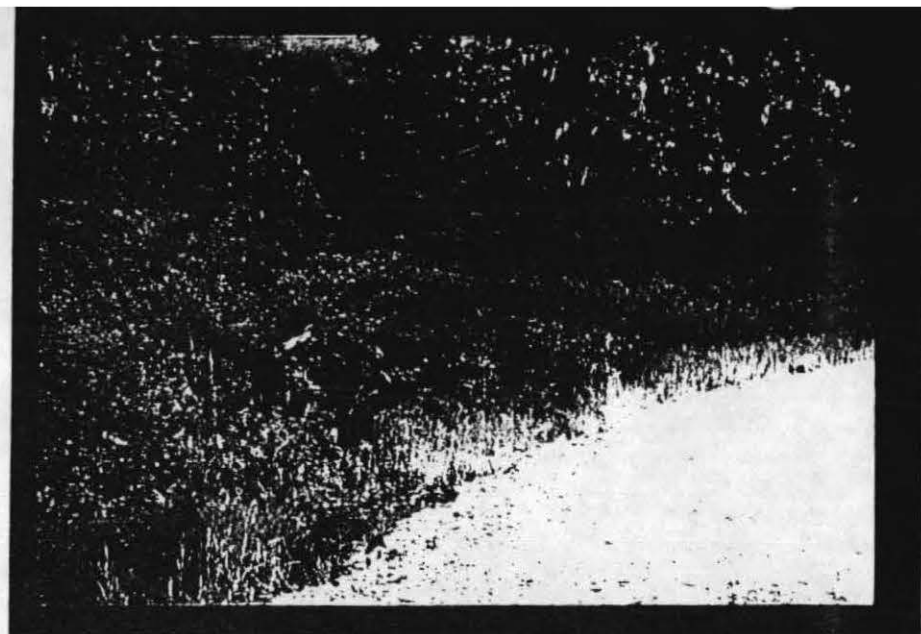
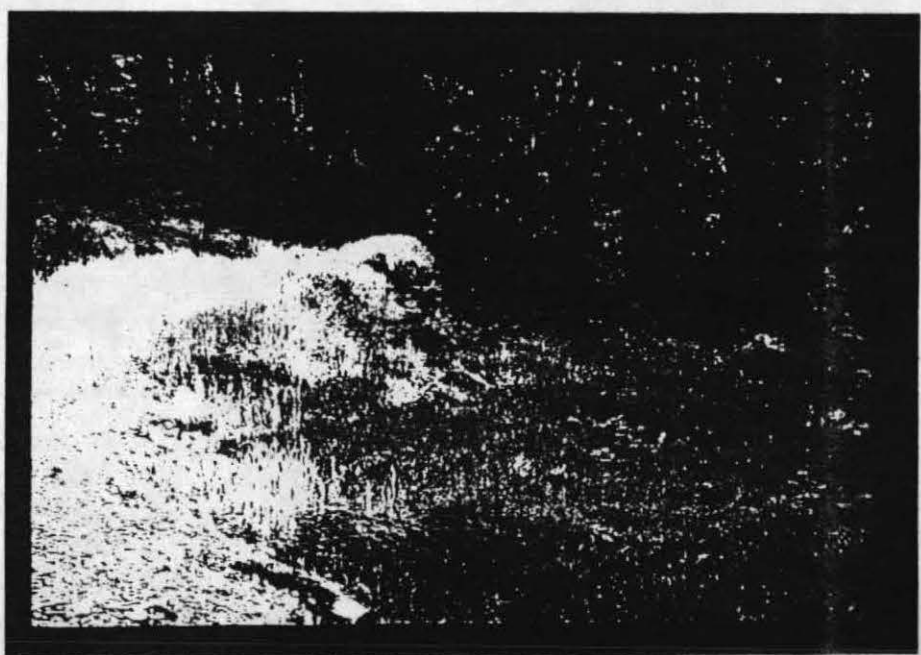
Plate 1 Corner Bay, Chichagof Island

- a) Corner Bay (near CC9807) Invasion of *Phalaris arundinaceae* (brilliant light-green foliage) onto a sloping fen downslope from a culvert. Notice the limited extent of the *Phalaris* flush, which is invading a fen lawn dominated by *Scirpus cespitosus*.

- b) Corner Bay (near CC9807). Restriction of planted *Phalaris arundinaceae* (brilliant light-green foliage) to the shoulder of a roadway. The nonforested area in the background is a fen lawn dominated by *Scirpus cespitosus*.

- c) Corner Bay (site CC 9805). Extensive flush of *Phalaris arundinaceae* (brilliant light-green foliage) and other "exotics" that have invaded a steeply sloping peatland downslope from a culvert. The culvert is probably a point source for mineral sediment as well as fertilizer that is/was transported onto the peatland downslope within storm runoff.

- d) Corner Bay (near site CC9807). Swards of *Phalaris arundinaceae* (brilliant light-green foliage) line the road margins adjacent to a nonforested fen lawn. Notice the restricted growth and discontinuous clumps of *Phalaris* that indicate the decline of these swards.

Significant vegetation impacts are largely restricted to the immediate vicinity of a roadway (shoulders and berm) or localized zones where discharge from a culvert creates a flush of *Carex livida* or *Phalaris arundinaceae*. The roadside shoulders and berms provide a better-drained substrate of bare mineral soil that was colonized (or planted) by non peatland plants. On Chichagof Island, for example reed canary grass (*Phalaris arundinaceae*) has been planted along many roadsides. These stands of grass usually do not persist, except for the rare case (site CC9805) where a flush of reed canary grass and

other species actually spread in a plume-like flush from the outlet of a culvert onto the peatland downslope. The mineral shoulders of these roadways are often colonized by ferns, upland vascular plants, and conifers. A strip of shore pines (*Pinus contorta*), for example has developed along the shoulders and berms of the road that crosses one of the Wrangell study sites (W9813). The robust growth of these trees is probably related to the better drainage produced by the slope on the downslope side of the road and also the exposed mineral soil. Other than blocking a fine scenic view, the impact of this pine stand on the landscape is probably minimal.

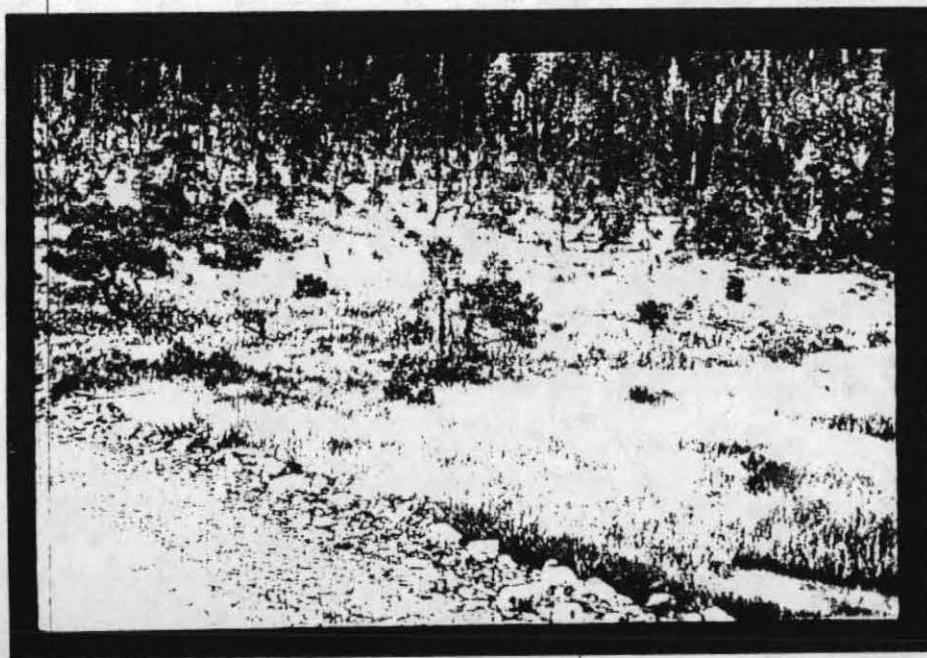
Plate 2, Corner Bay, Chichagof Island and Kupreanof Island

- a) Kupreanof Island (site K9810). Intact poor-fen vegetation growing in contact with road materials. The peatland species visible include *Scirpus cespitosus*, *Fauria crista-galli*, and *Pinus contorta*.
- b) Corner Bay (site CC9805). Extensive flush of *Phalaris arundinaceae* (brilliant light-green foliage) arising downslope from the mouth of a culvert.
- c) Kupreanof island (site K9810). A flush of *Carex livida* (blue-gray foliage) arising downslope from a culvert. Notice the contrast between the stand of *C. livida* and the darker foliage of the *Scirpus cespitosus* dominated poor-fen in the background.

- d) Kupreanof island (site K9810). Roadside with nearly intact poor-fen vegetation. The nonforested lawn of *Scirpus cespitosus* contains local clumps of stunted *Pinus contorta*.

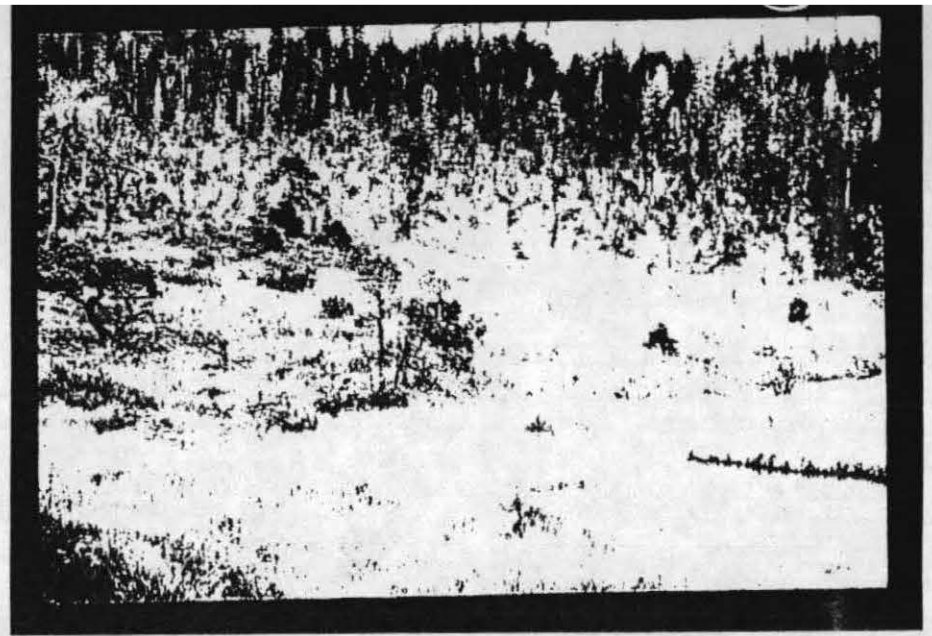
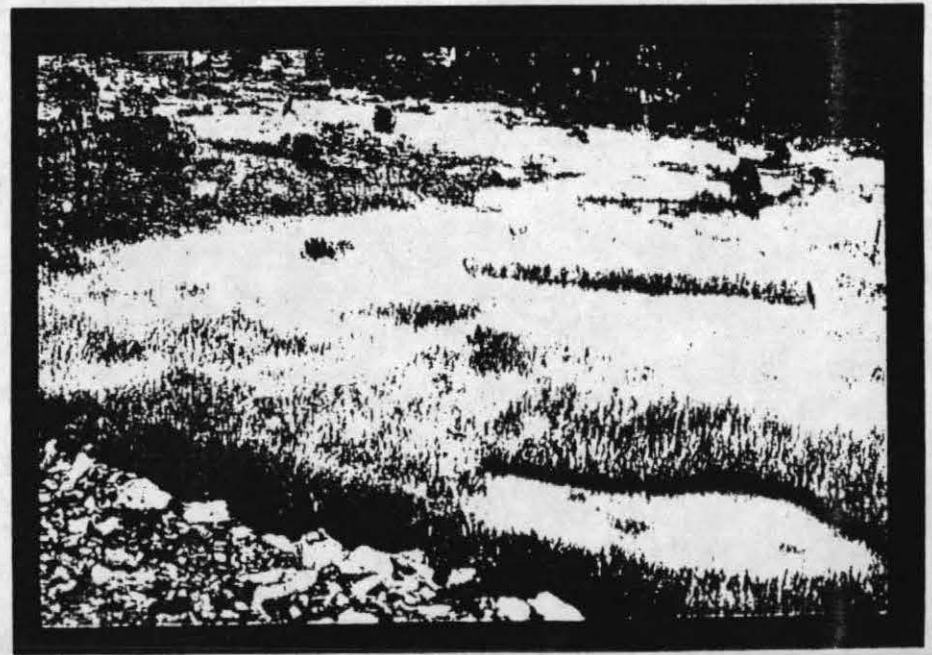
Plate 3, Kupreanof Island

- a) Fen pool (site K9810) downslope from a culvert with a population of *Sparganium angustifolium*. The edges of the pool are lined with *Carex livida* (gray-green shoots), *Scirpus cespitosus* (yellow-brown foliage), *Fauria crista-galli*, and *Pinus contorta*.

- b) Flush of *Carex livida* (gray-green zone in the foreground) in a small water track arising downslope from a culvert (site K9810). Notice the sharp boundary between the *Carex livida* flush and the *Scirpus cespitosus* lawn (yellow-to-brownish green foliage) in the background with scattered clumps of *Pinus contorta*.

- c) Oblique aerial photograph of sloping peatlands with networks of pools along the Bohemia Mountain road (FR 6030) on Kupreanof Island. There are no visible changes in peatland vegetation and landforms associated with the roadway.

- d) Another view of the *Carex livida* flush from Plate 3b above. Notice the narrow stand of *Scirpus cespitosus* (yellow-green foliage) along the edge of the roadway and the oriented pools in the water track itself.
